COVER FEATURE

Under the Crosstown: Remediating the Drilled Shaft Foundations for Tampa, Florida's Lee Roy Selmon Crosstown Expressway

By Steven "Keith" Anderson,
Operations Manager,
A.H. Beck Foundation Co., Inc.
and
Ross T. McGillivray, P.E.,
Chief Engineer, Tampa,
Ardaman & Associates, Inc.

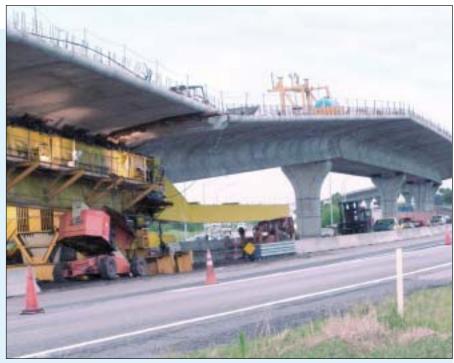
Foundation failure at Bent 97 - April 13, 2004. Photo courtesy of PCL Civil Constructors.

support piers plunged into the ground, dropping two adjoining bridge spans. Investigators would later discover that major remediation efforts were required for 68 of the bridge's original 224 foundations as well as the installation of 14 foundations not completed prior to the start

The Expressway Authority's geotechnical advisors first assumed that the failure was caused by an undetected geologic anomaly (a "sinkhole") 70 feet or more below ground, below the Pier 97 foundation. The Authority contracted with Ardaman & Associates, an ADSC Technical Affiliate Member, and a nationally recognized engineering firm specializing in geotechnical engineering and foundation design, to perform an independent "forensic" analysis to determine the cause of the settlement. However,

the pattern of settlement indicated that the strength limit of the drilled shaft may have been reached. The Authority now became concerned about the integrity of all the deep foundations under the structure. The Authority ordered an immediate halt to construction on the bridge and expanded Ardaman's responsibilities to include evaluation of all of the existing 204 foundations. By September, Ardaman reported its conclusion that the drilled shaft supporting Pier 97 was founded in a weak formation consisting of interbeded weathered rock lenses and soil, not competent limestone. Ardaman's forensic investigation conclusively determined that there was no structural flaw or failure in the Pier 97 foundation before or after the settlement; the failure had occurred in weak soil and rock supporting the foundation.

of remedial work. (For this project, a "major" remediation was classified as a foundation with a calculated capacity 1,000 tons or more below the required capacity.) These foundations were to be repaired by installing two 48-inch diameter sister shaft founda-

These foundations were to be repaired by installing two 48-inch diameter sister shaft foundations to varied depths. The new sister shafts would be tied to the deficient shafts with post tensioned caps.

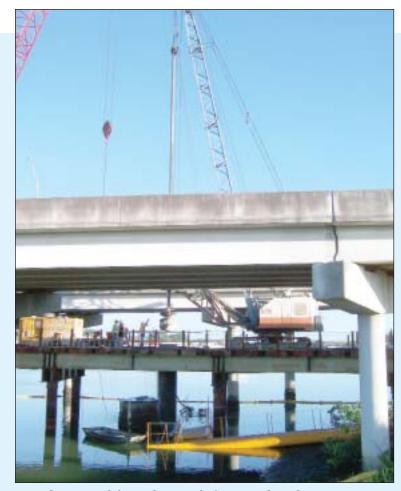
Remediation work being done on shafts out in the Palm River.

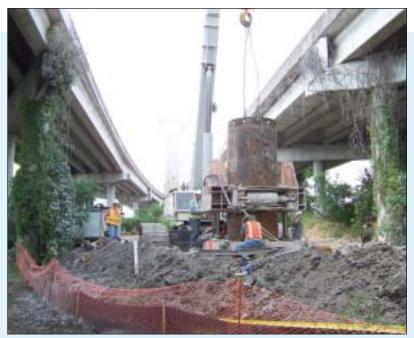
Even the areas with no overhead obstructions were tight to access and difficult to maneuver through because of the existing structures and foundations.

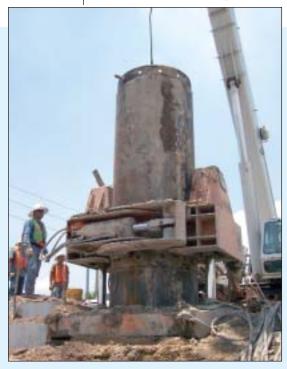
Casing being extracted after concrete placement.

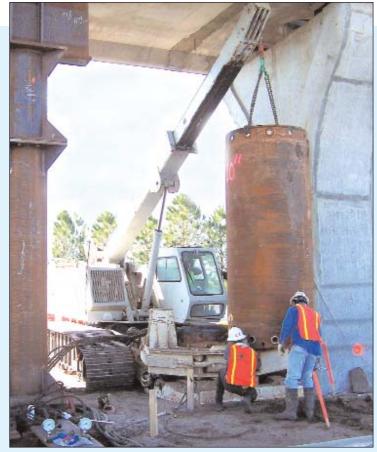
BECK-modified casing oscillator used to advance casings down to the limestone.

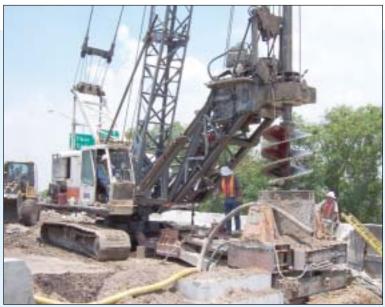
BECK-manufactured hydraulic crane attachment mounted on a Northwest 5045 working on remediation shafts with no overhead obstructions.

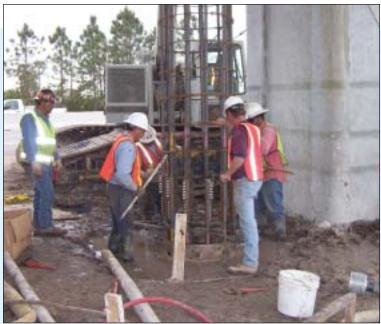
Rebar cage consisting of (12) #18 vertical bars being spliced together with mechanical couplers.
